Abdominal skeletal muscle twitching due to current leak from a pacemaker extension connector box

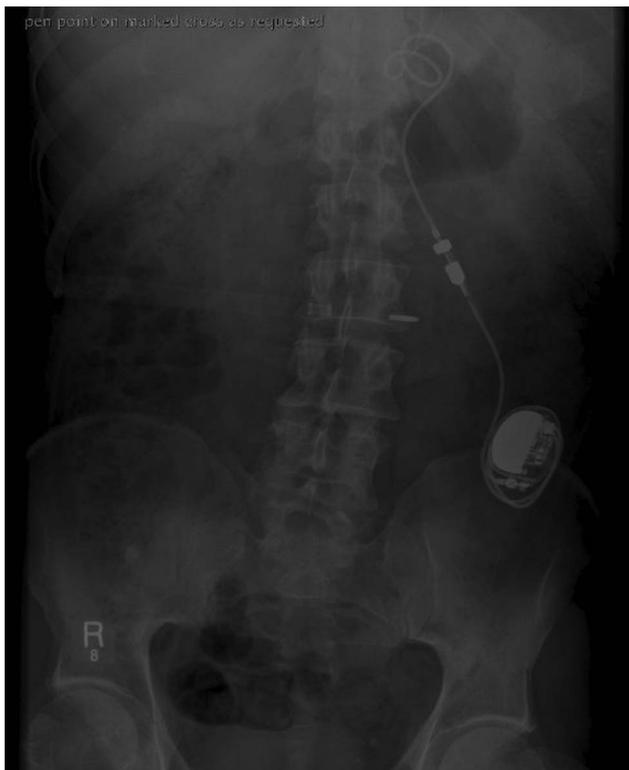
Figure 1 A radio-opaque marker was placed over the site of maximal abdominal twitching and appeared to overlie a lead fracture.

Lead impedance had fallen from 746 to 562 Ohms suggestive of a current leak. A radio-opaque marker was placed over the site of maximal twitching on abdominal x-ray (figure 1) which appeared to overlie a lead fracture and so the patient was admitted electively for surgical exploration. During the operation, no fracture could be identified but rather the large screws used to secure the existing lead to the connector box were exposed resulting in a current leak. Figure 2 shows the surgeon placing medical adhesive over one of the screws. Due to the infrequent use of this equipment, the insulating glue was overlooked at the time of initial implantation. This case illustrates the need for a full understanding of all pacing hardware not in routine use prior to the start of a case and the importance of close collaboration between surgeons and pacing specialists when the need arises.

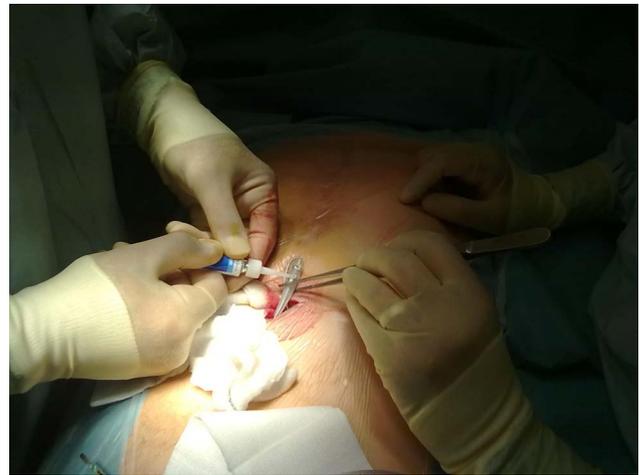
Figure 2 Surgeons place medical insulating glue over the bare screws which caused the current leak.
