## Giant sinus of Valsalva aneurysm: the role of multimodality imaging

*Heart Asia* 2013;0:188. doi:10.1136/heartasia-2013-010380

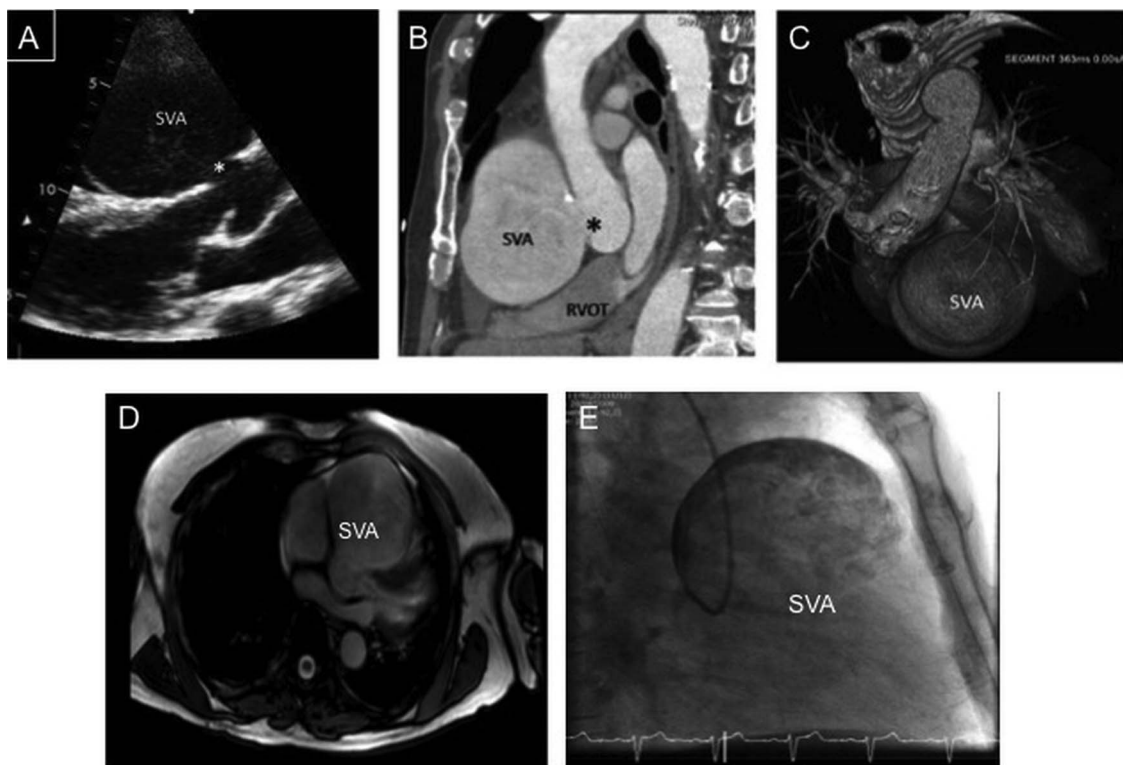
**Figure 1** (A) Parasternal long-axis echo view. A defect (\*) can be identified in the aortic root extending into the sinus of Valsalva aneurysm (SVA). Right ventricular outflow tract (RVOT) compression by SVA detected by cardiac CT (B) with three-dimensional CT reconstruction (C). Cardiac MRI image of SVA (D). Left anterior oblique fluoroscopic view of SVA (E) outlined by contrast injection from coronary catheter within the SVA.

An 82-year-old man presented with severe exertional breathlessness to the outpatient clinic. Previous medical history included hypertension and transient ischaemic attack. During routine workup, transthoracic echocardiography was performed. A large defect (\*) in the anterior wall of the aortic sinus of Valsalva was identified (figure 1A) which extended into a cavity containing spontaneous echo-contrast (see online supplementary data video S1). Further imaging by CT with three-dimensional reconstruction (figure 1B,C) and cardiac magnetic resonance (figure 1D) delineated the defect to extend into a giant sinus of Valsalva aneurysm (SVA) measuring  $(8.3 \times 7.5 \times 10 \text{ cm})$ . The body of the aneurysm was causing extrinsic right ventricular outflow tract compression resulting in symptoms. Coronary angiography failed to identify the right coronary artery. The coronary catheter repeatedly entered the body of the aneurysm via a large defect in the right aortic sinus of Valsalva. Contrast injection demonstrated a smooth-walled aneurysmogram (figure 1E and see online supplementary data videos S2 and S3). Surgical reconstruction was performed by direct defect patch closure and bioprosthetic aortic valve replacement. The patient had an uncomplicated recovery from surgery and remains well at 2-year follow-up.
