A change in QRS morphology in right ventricular apical pacing: is it a red flag sign?

Rakesh Jain, Sandeep Mohanan, Vellini Haridasan, Gopalan Nair Rajesh, Krishnan Mangalath Narayanan, Kalathingathodika Sajeer

Department of Cardiology,
Government Medical College,
Kozhikode, Kerala, India

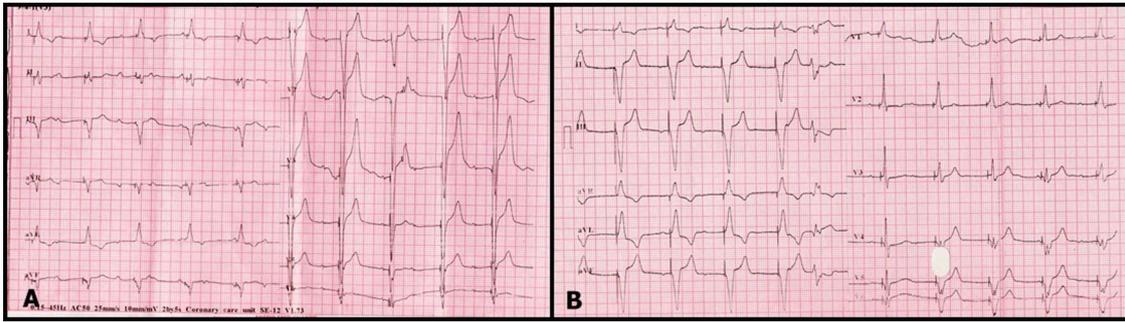
Figure 1 (A) Postoperative 12-lead ECG showing full capture with the expected left bundle branch block QRS morphology. (B) Right bundle branch block QRS morphology with QRS axis on the frontal plane of around -80° , V1 and V2 showing R and Rs complex, respectively.

The universally accepted rule that RV pacing will produce LBBB and left ventricle (LV) pacing of an RBBB pattern on a surface ECG may not always be correct. Paced RBBB QRS morphology in patients with RV apical pacing is usually indicative of inadvertent LV pacing through intracardiac defects such as patent foramen ovale, a ventricular septal defect. Sometimes it may represent coronary sinus pacing.^{1–2} However, a red flag is often raised to rule out a septal or free wall perforation. Although rare, uncomplicated RV apical pacing may paradoxically show RBBB QRS morphology.³ This may be reassuring if the frontal plane maximal QRS vector orientation is to the left. Still, an alarm must be sounded if a new right inferior orientation of the QRS axis is seen.⁴ Degree of frontal axis plane deviation on an ECG can be used to localise the site of pacing. Uncomplicated RV apical pacing is said to be present if the frontal axis plane is between 0° and -90° and precordial transition is at V3 with a sensitivity of 86% and specificity of 99%, while a transition at V4 may indicate middle cardiac vein pacing with a sensitivity of 72% and specificity of 100%. When a frontal plane axis occurs between -90° and -180° , LV pacing is more likely.⁵

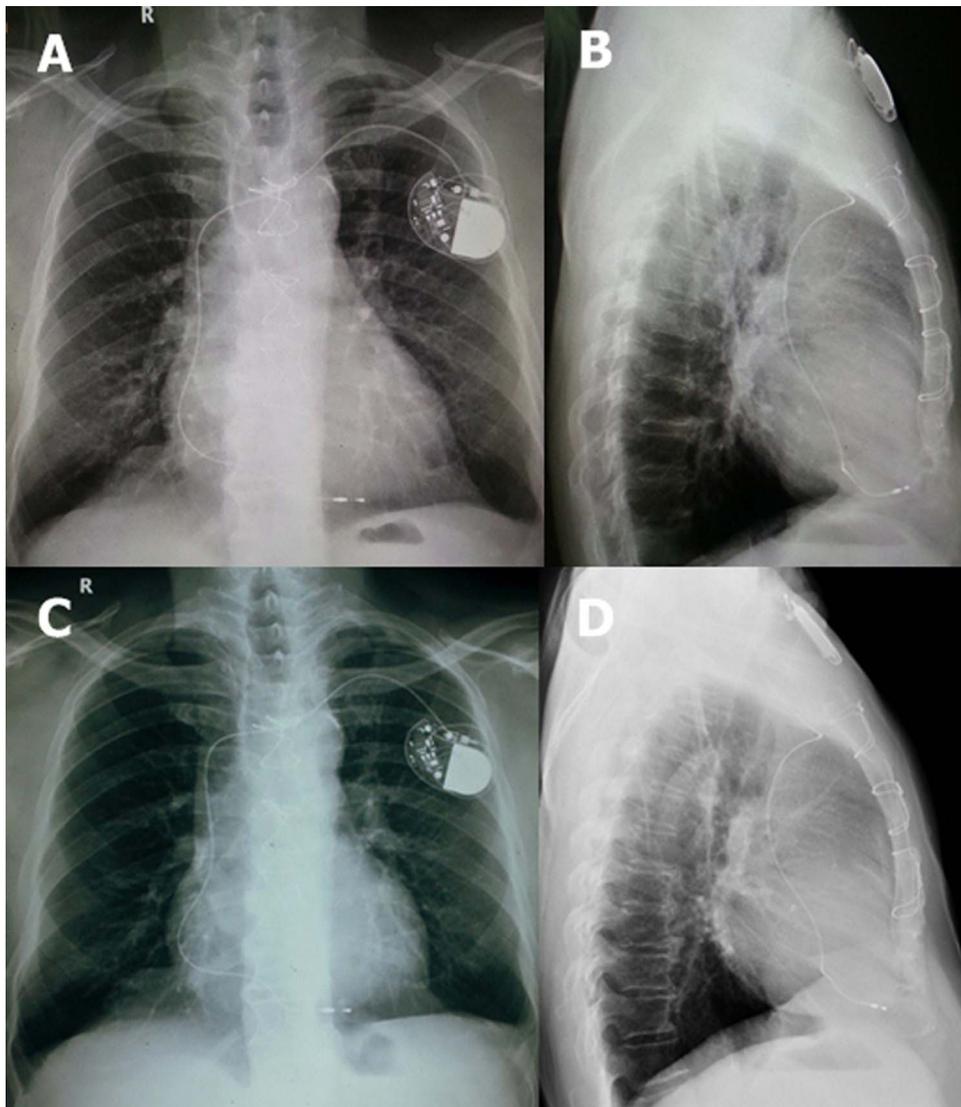
Figure 2 Chest X-ray posterior–anterior view (A) and left lateral view (B) taken on the third postoperative day showing the pacemaker lead at the right ventricular (RV) apex. Chest X-ray posterior–anterior view (C) and left lateral view (D) taken at the 2-month follow-up showing the appropriate RV apical position of the pacemaker lead and no evidence of lead displacement.
