Images in cardiovascular medicine

Multiple fistula and abnormal vascular plexus

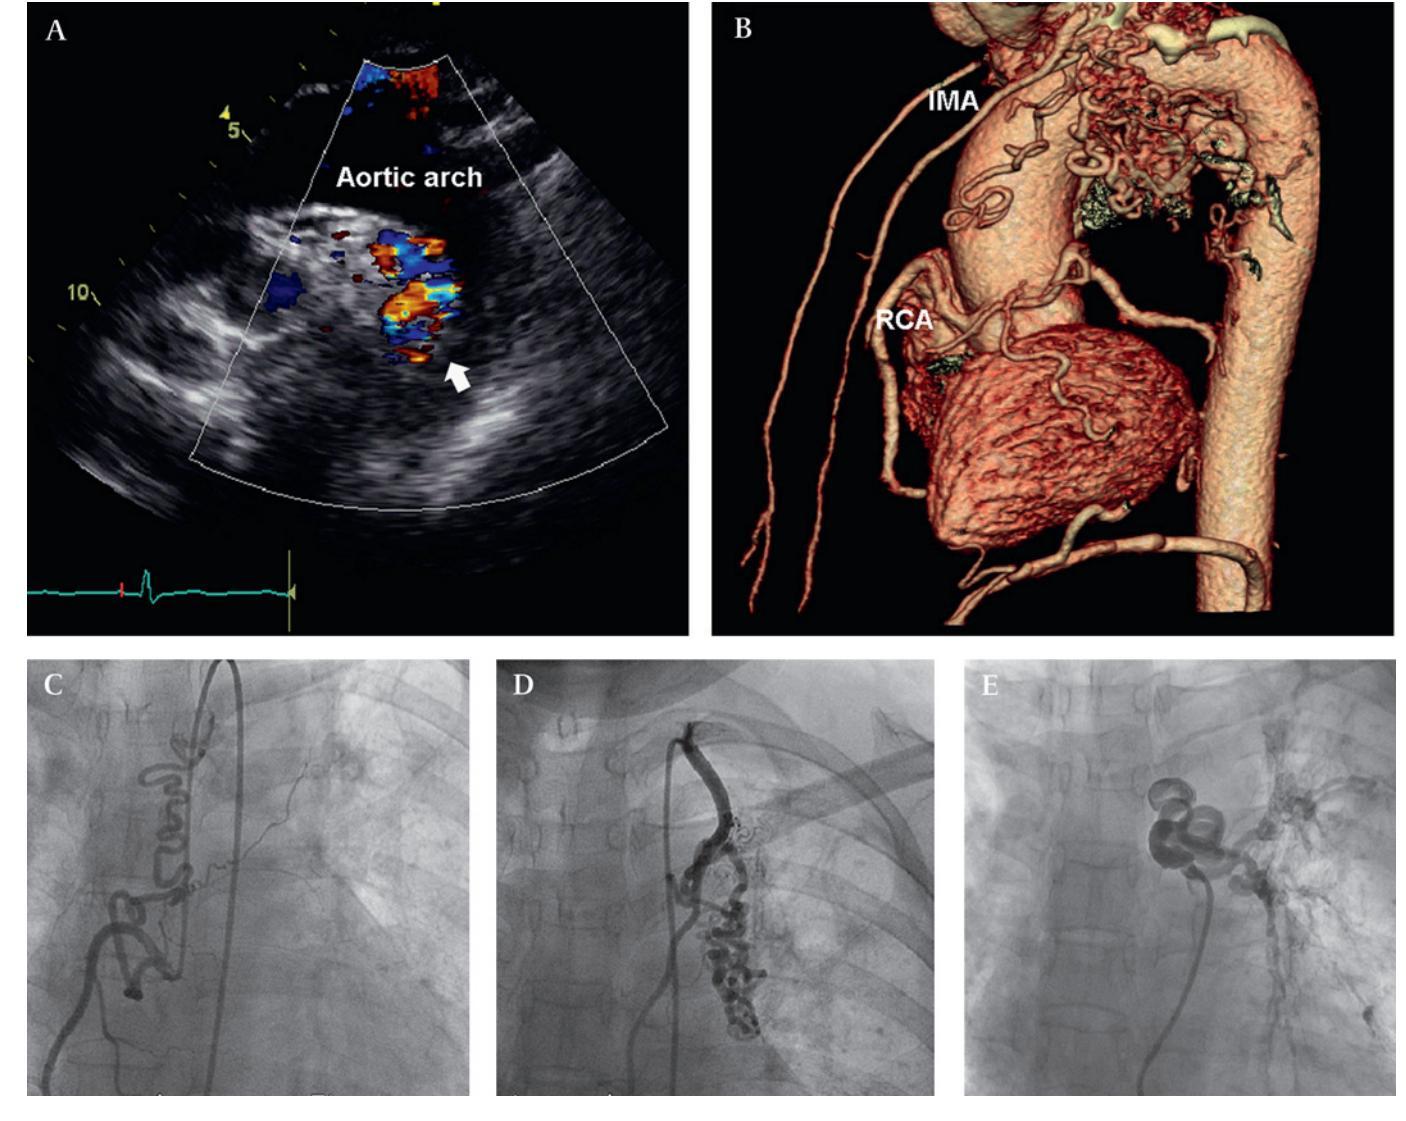
Figure 1 Transthoracic echocardiography, CT angiography and right coronary angiography of the patient.

A 50-year-old female was admitted to the hospital for the preoperative evaluation. She complained of mild dyspnoea on exertion for years. Cardiovascular examination was unremarkable. Transthoracic echocardiography revealed abnormal continuous flow at the anterior side of proximal descending aorta (figure 1A, arrow). A CT angiography using 128-multidetector computed tomography (MDCT) was performed to evaluate the abnormal vascular network, and it showed a complex vascular plexus which was communicating with the right coronary artery (RCA), left internal mammary artery (IMA) and bronchial artery (figure 1B). Right coronary angiography showed a hyperplastic conus branch which was draining directly into pulmonary artery (PA) (figure 1C). Left internal mammary angiography

revealed a vascular plexus shaped like a bunch of grapes which communicated with the PA (figure 1D). Bronchial artery was also hyperplastic and drained into pulmonary artery and bronchial vein (figure 1E).
