Giant sinus of Valsalva aneurysm: the role of multimodality imaging

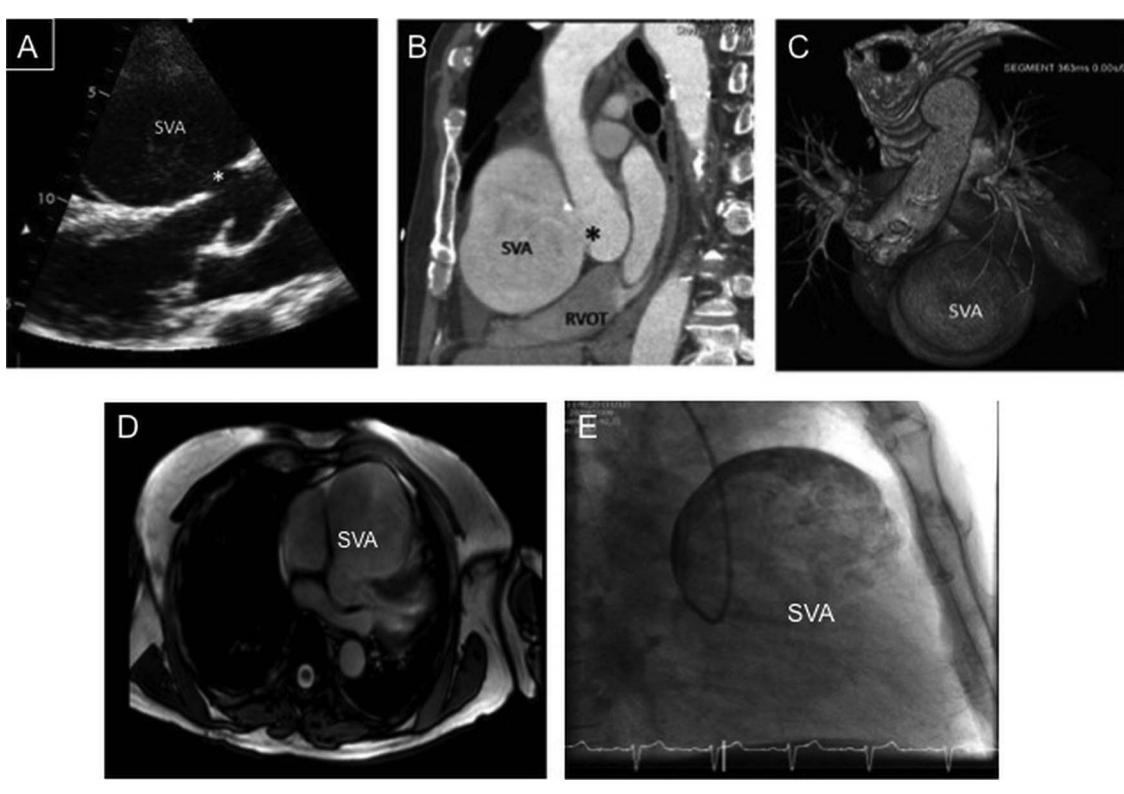
Figure 1 (A) Parasternal long-axis echo view. A defect (*) can be identified in the aortic root extending into the sinus of Valsalva aneurysm (SVA). Right ventricular outflow tract (RVOT) compression by SVA detected by cardiac CT (B) with three-dimensional CT reconstruction (C). Cardiac MRI image of SVA (D). Left anterior oblique fluoroscopic view of SVA (E) outlined by contrast injection from coronary catheter within the SVA.

An 82-year-old man presented with severe exertional breathlessness to the outpatient clinic. Previous medical history included hypertension and transient ischaemic attack. During routine workup, transthoracic echocardiography was performed. A large defect (*) in the anterior wall of the aortic sinus of Valsalva was identified (figure 1A) which extended into a cavity containing spontaneous echo-contrast (see online supplementary data video S1). Further imaging by CT with three-dimensional reconstruction (figure 1B,C) and cardiac magnetic resonance (figure 1D) delineated the defect to extend into a giant sinus of Valsalva aneurysm (SVA) measuring $(8.3 \times 7.5 \times 10 \text{ cm})$. The body of the aneurysm was causing extrinsic right ventricular outflow tract compression resulting in symptoms. Coronary angiography failed to identify the right coronary artery. The coronary catheter repeatedly entered the body of the aneurysm via a large defect in the right aortic sinus of Valsalva. Contrast injection demonstrated a smooth-walled aneurysmogram (figure 1E and see online supplementary data videos S2 and S3). Surgical reconstruction was performed by direct defect patch closure and bioprosthetic aortic valve replacement. The patient had an uncomplicated recovery from surgery and remains well at 2-year follow-up.
