# A change in QRS morphology in right ventricular apical pacing: is it a red flag sign?

Rakesh Jain, Sandeep Mohanan, Vellini Haridasan, Gopalan Nair Rajesh, Krishnan Mangalath Narayanan, Kalathingathodika Sajeer

Department of Cardiology, Government Medical College, Kozhikode, Kerala, India

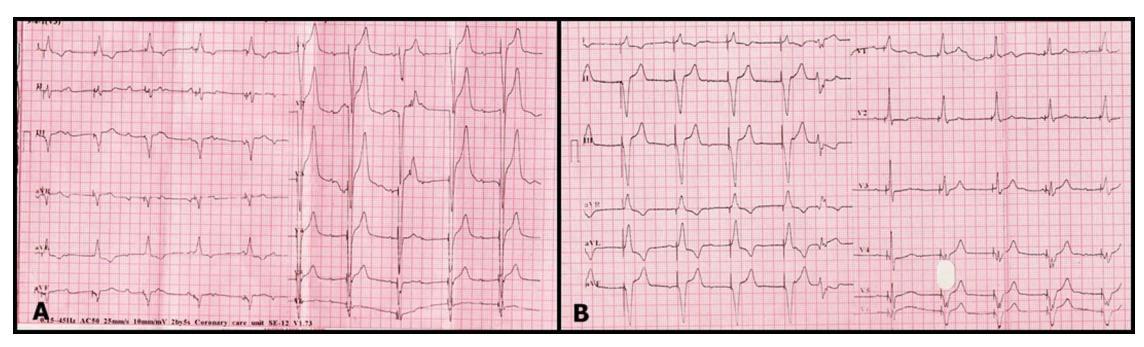
Figure 1 (A) Postoperative 12-lead ECG showing full capture with the expected left bundle branch block QRS morphology. (B) Right bundle branch block QRS morphology with QRS axis on the frontal plane of around -80°, V1 and V2 showing R and Rs complex, respectively.

A 74-year-old man with symptomatic broad complex complete heart block with baseline RBB QRS morphology underwent successful RV apical permanent pacemaker implantation (VVI mode, bipolar lead; St Jude Medical) with an uneventful postoperative period. A 12-lead ECG showed full capture with the expected LBBB QRS morphology (figure 1A). The ventricular capture threshold was 0.5 V and lead impedance was  $674 \Omega$ . At routine follow-up at 2 months, ECG showed all captured beats but with RBBB QRS morphology (figure 1B). The QRS axis in the frontal plane was -80°. The patient was stable and had no presyncopal or syncopal events. He was admitted for evaluation and pacemaker interrogation, as lead perforation and displacement was strongly suspected. His haematological and biochemical evaluations were normal. Chest X-ray (figure 2A-D), echocardiography and fluoroscopy showed an appropriate RV apical position of the pacemaker lead. On pacemaker interrogation, all pacemaker parameters were within normal limits (ventricular threshold, 0.75 V; lead impedance,  $477 \Omega$ ). The patient remained asymptomatic while under observation and was discharged after reassurance regarding the normalcy

We report a case of RV apical pacing where the QRS morphology shifted from RBBB to LBBB raising the suspicion of lead perforation. However, the frontal plane QRS axis of  $-80^{\circ}$  suggested correct RV pacing. This was also supported by an appropriate pacemaker lead position on chest

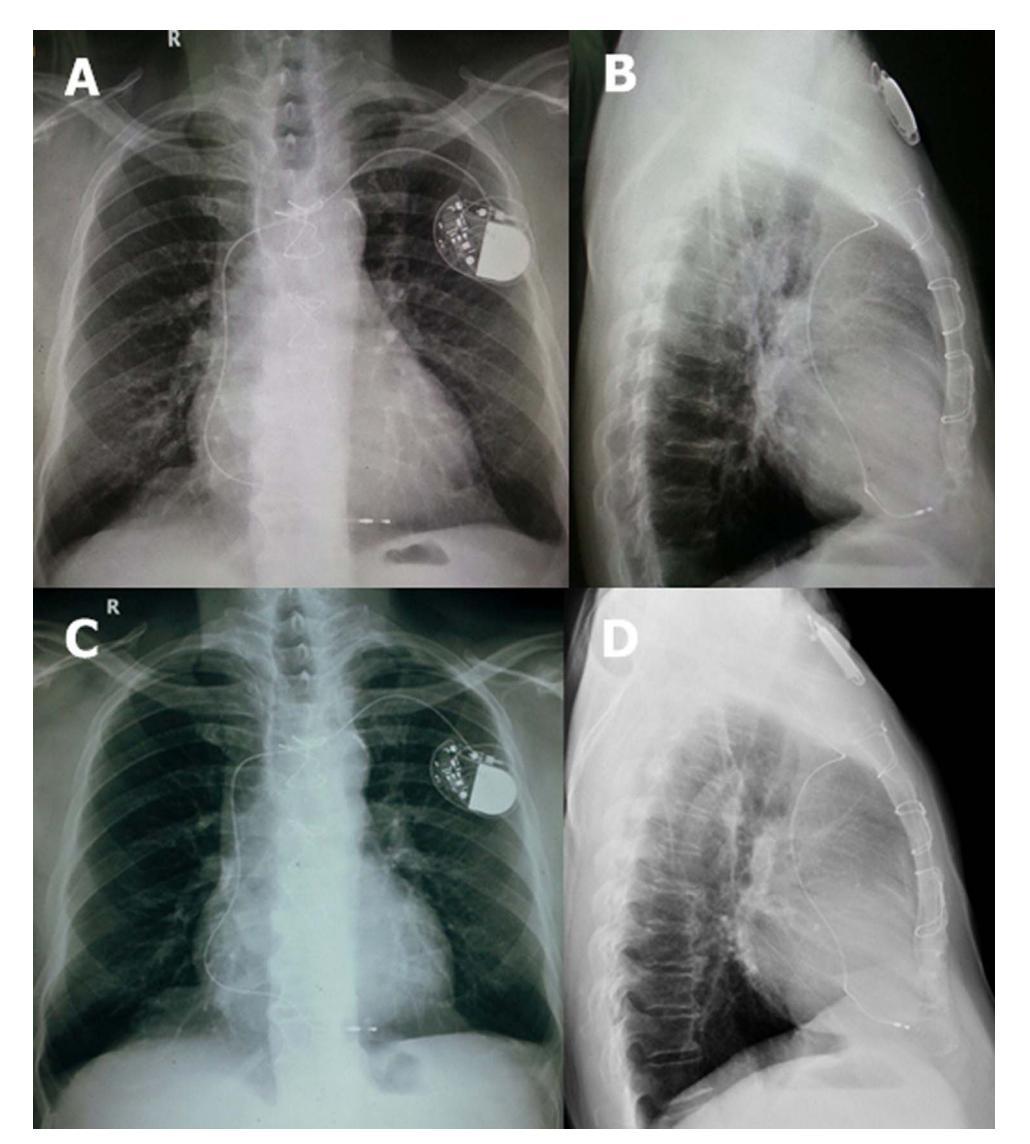
**Figure 2** Chest X-ray posterior—anterior view (A) and left lateral view (B) taken on the third postoperative day showing the pacemaker lead at the right ventricular (RV) apex. Chest X-ray posterior—anterior view (C) and left lateral view (D) taken at the 2-month follow-up showing the appropriate RV apical position of the pacemaker lead and no evidence of lead displacement.

X-ray, echocardiography and fluoroscopy with no significant changes in pacemaker parameters on pacemaker interrogation. Careful analysis of the surface ECG may obviate unnecessary hospitalisation. **Contributors** All the authors were equally involved in data collection, data interpretation and preparation of manuscript.
